**CONSENT ORDER
ISSUED UNDER THE
WATER POLLUTION CONTROL ACT
WEST VIRGINIA CODE, CHAPTER 22, ARTICLE 11**

TO: MarkWest Liberty Midstream & Resources, L.L.C. DATE: March 28, 2019
Gregory Bezdek, SVP, NE Region
4600 J Barry Ct. Ste 500
Canonsburg, PA 15317 ORDER NO.: 8945

MARKWEST LIBERTY MIDSTREAM & RESOURCES, L.L.C, WVR311004, Sherwood to Mobley
20" NGL, 8/22 & 8/23/2018

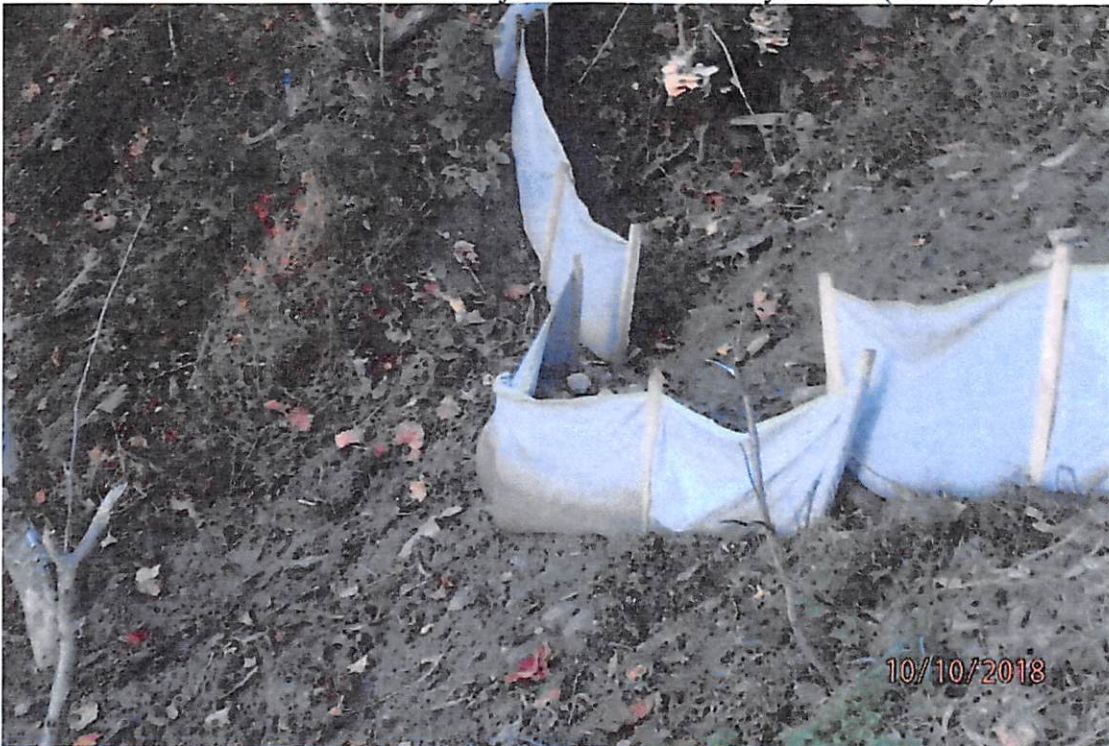
Overview of installed BMPs adjacent to UNT Buckeye Creek (UNT59).

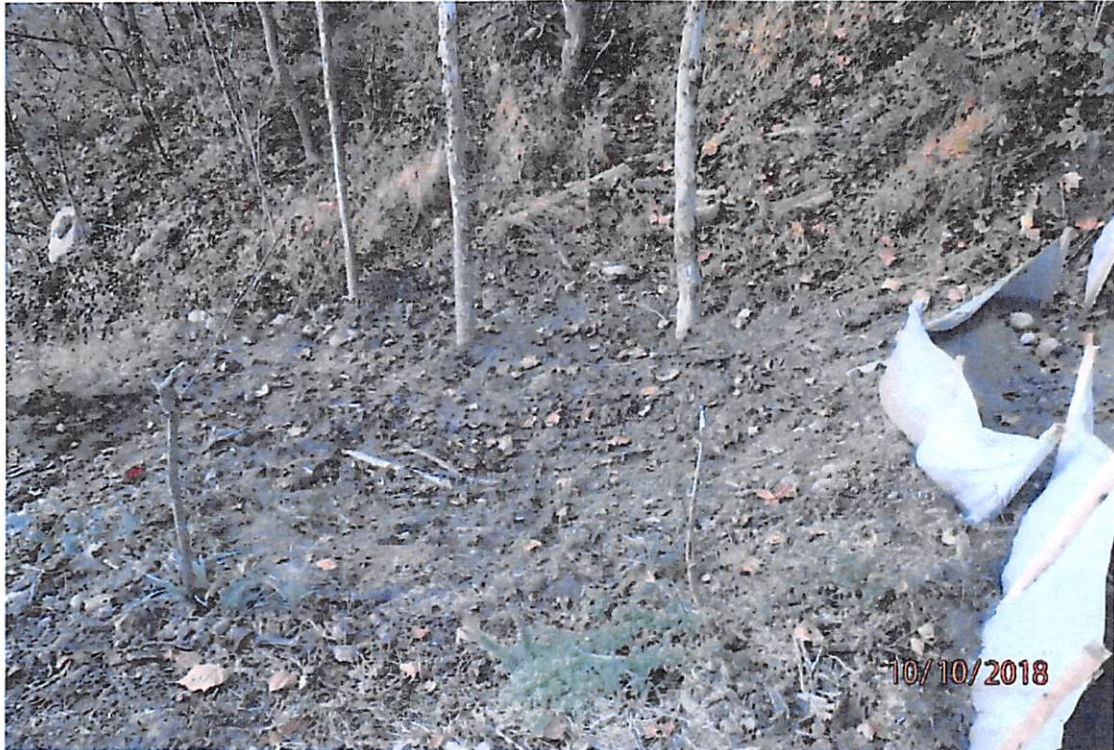
Overview of installed BMPs adjacent to UNT Buckeye Creek (UNT59) showing offsite sediment due to poor maintenance and improperly installed BMPs.

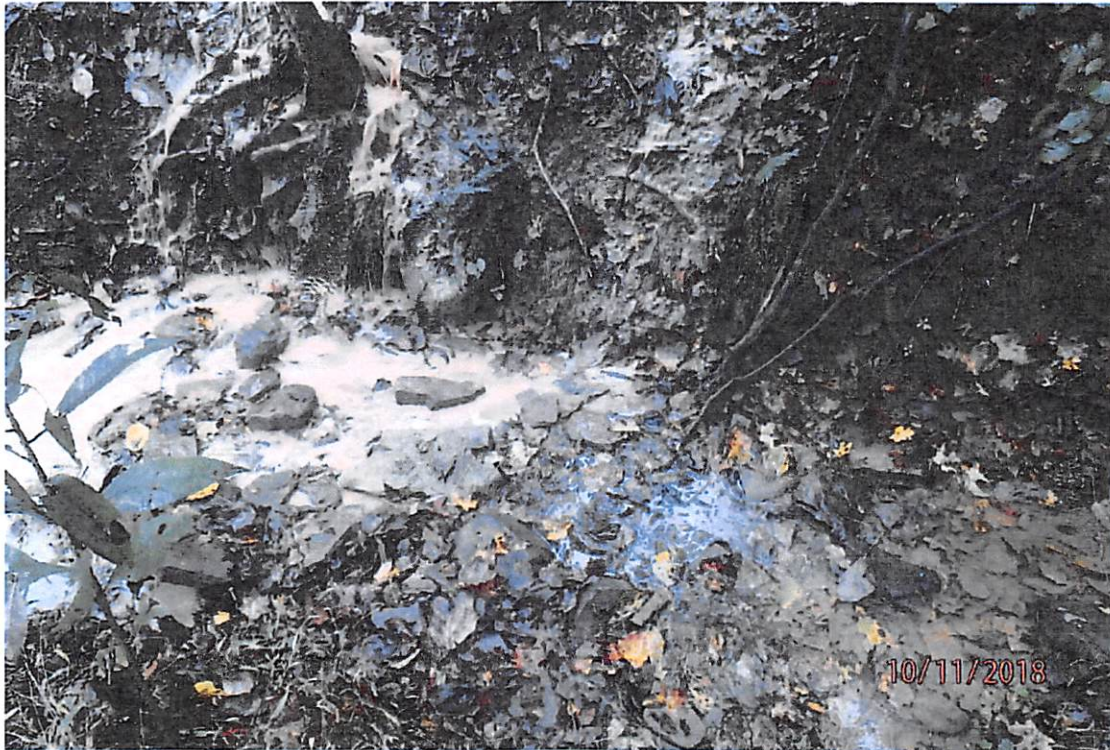
Sediment laden water bypassing an unmaintained and poorly operated water bar terminus BMP adjacent to UNT Franks Run (39°25.922' X 80°37.079').

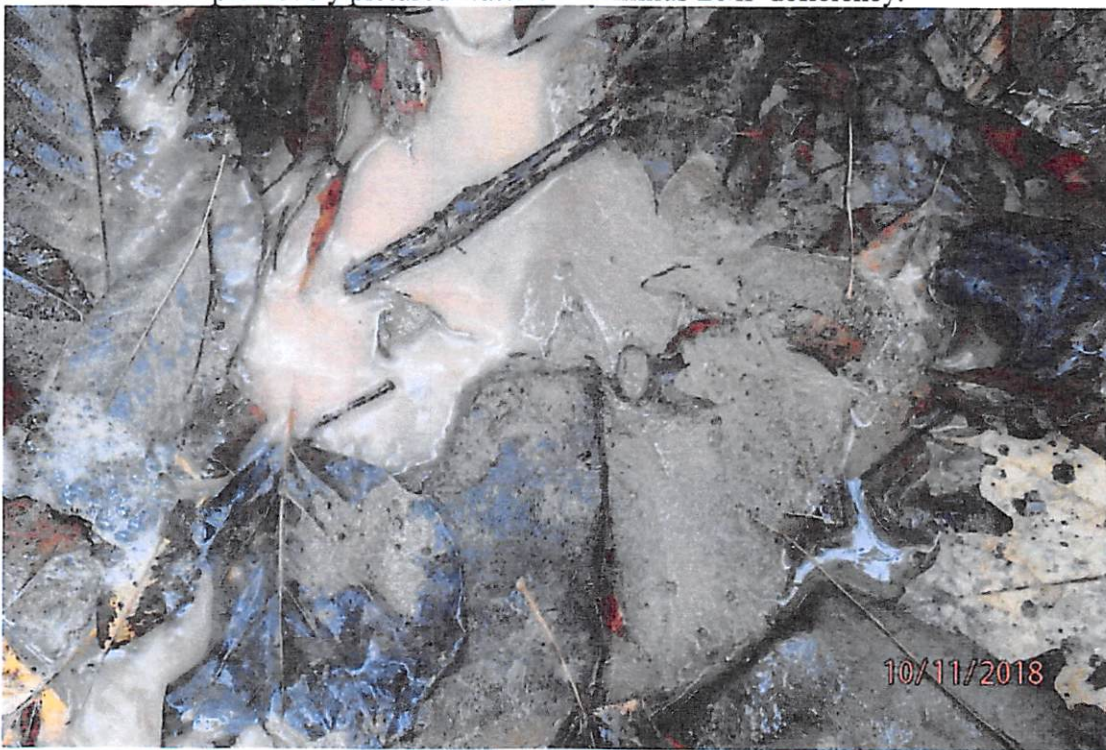
CNA distinctly visible settleable solids in UNT Franks Run (39°25.922' X 80°37.079') as a result of the previously pictured water bar terminus BMP deficiency.

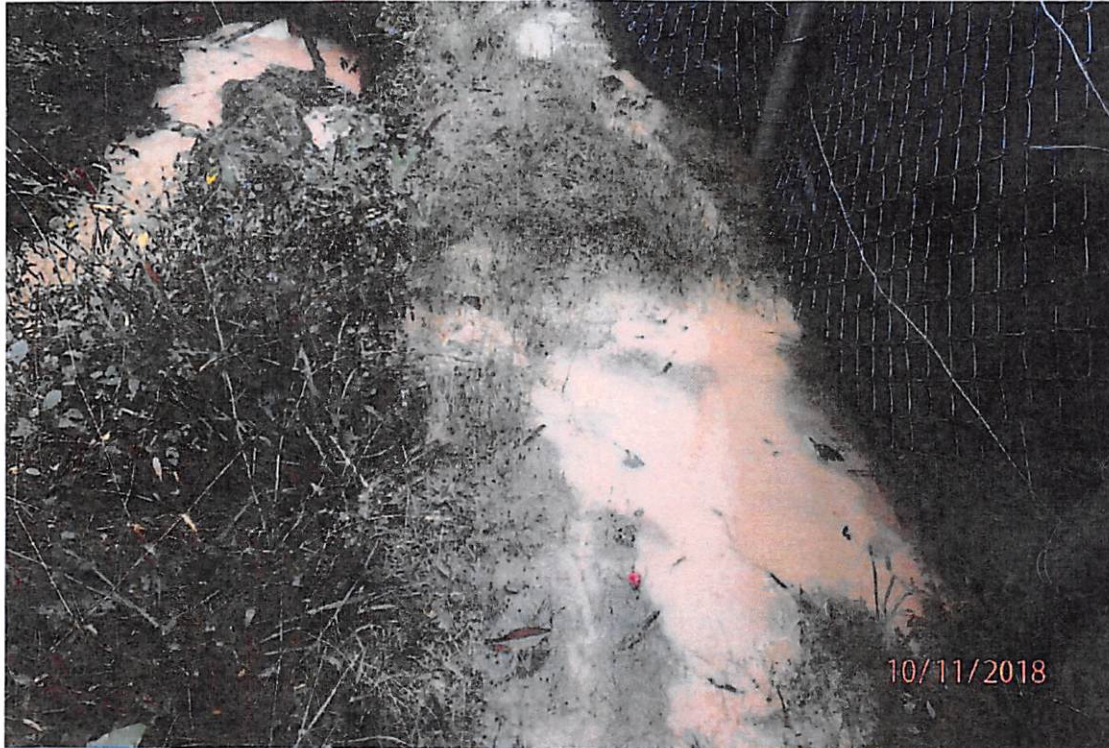
CNA deposits in UNT Franks Run (39°25.922' X 80°37.079') as a result of the previously pictured water bar terminus BMP deficiency.

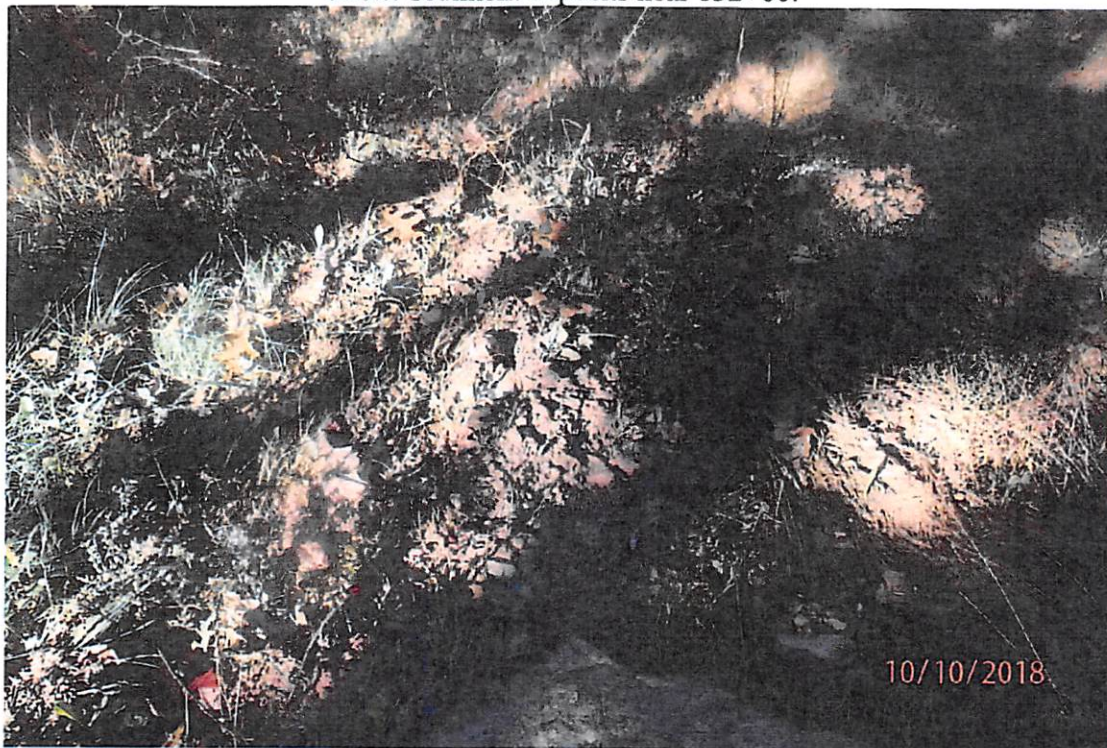
Diversion berm outlet BMP that has been overwhelmed and is in need of maintenance with associated offsite sediment deposits near 132+00.

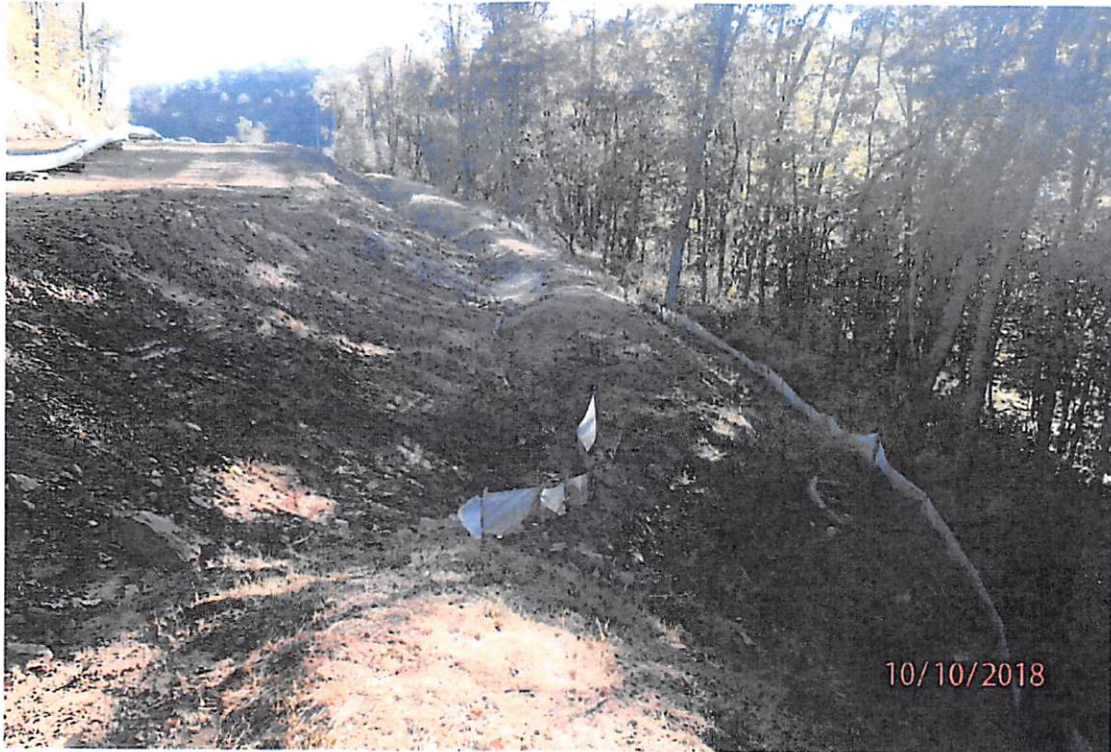
Offsite deposits as a result of above pictured deficiency near 132+00.

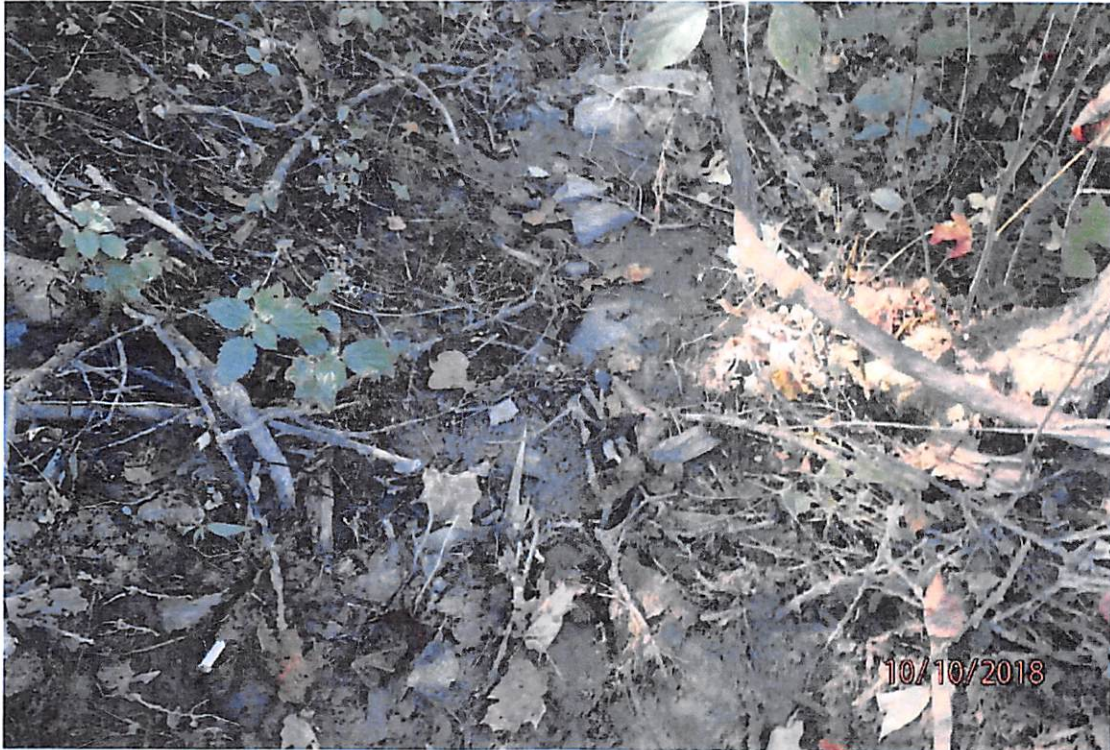
Diversion berm outlet BMP that has been overwhelmed and is associated with offsite CNA deposits near UNT Morgans Run (39°17.506' X 80°40.813').

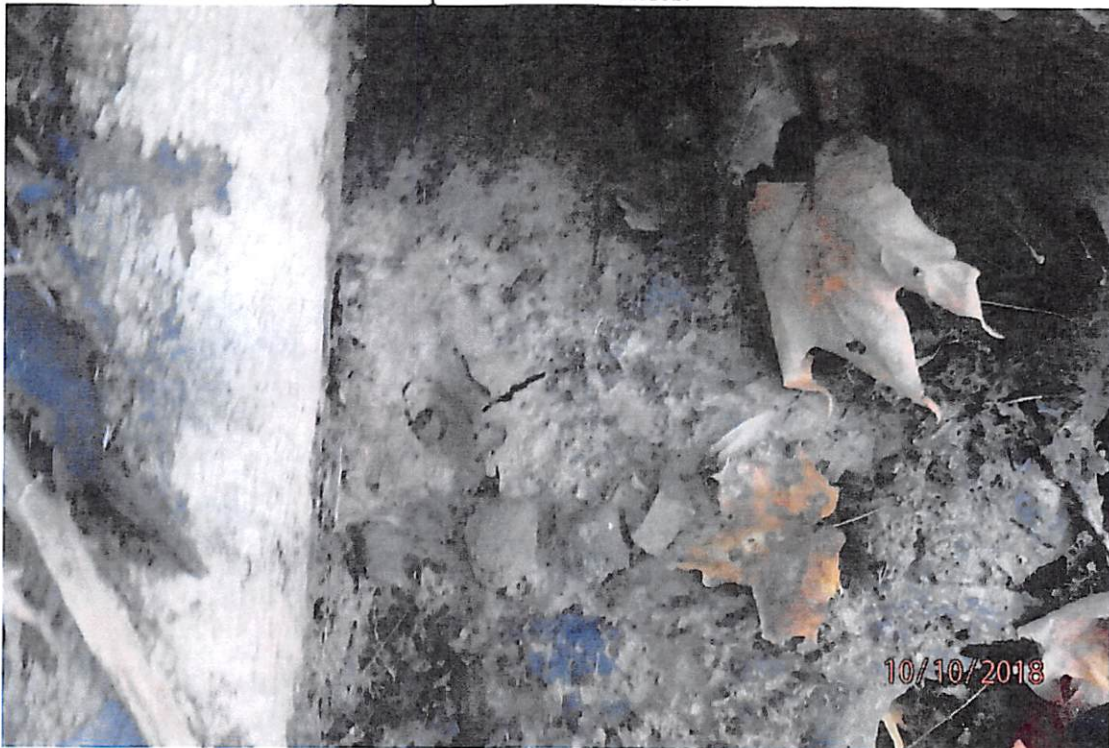
Offsite CNA deposits in UNT Morgans Run (39°17.506' X 80°40.813') as a result of the previously pictured deficiencies.

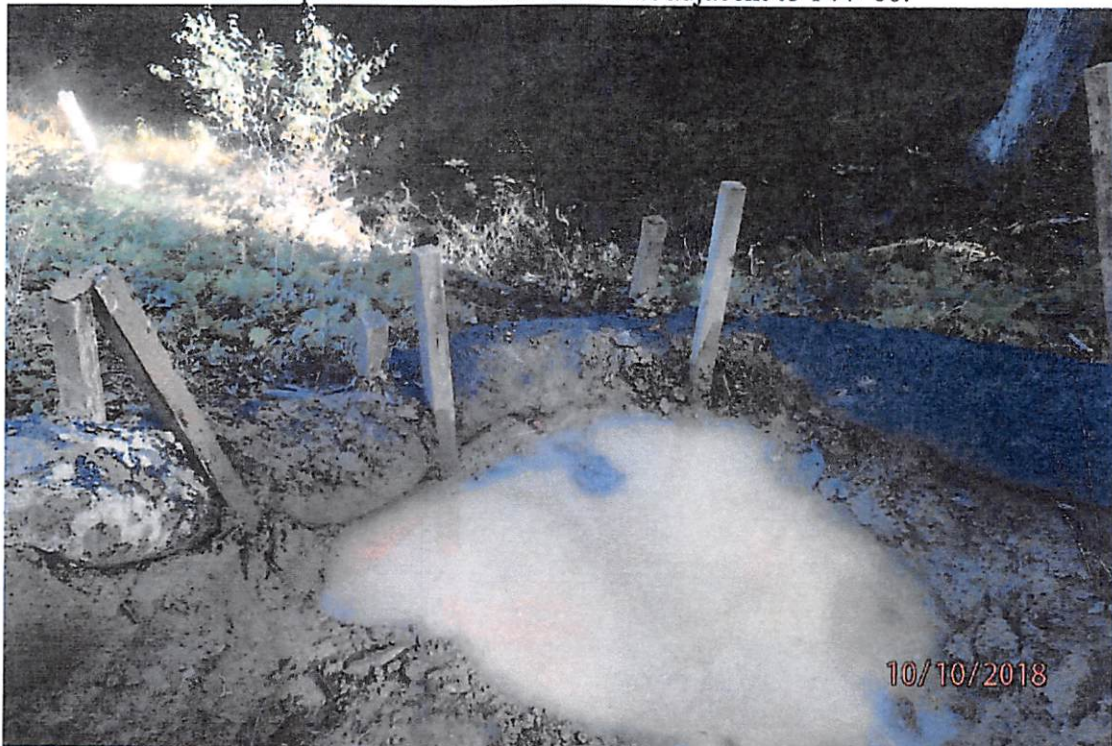
Fill slope erosion at water bar outlet adjacent to 144+00.

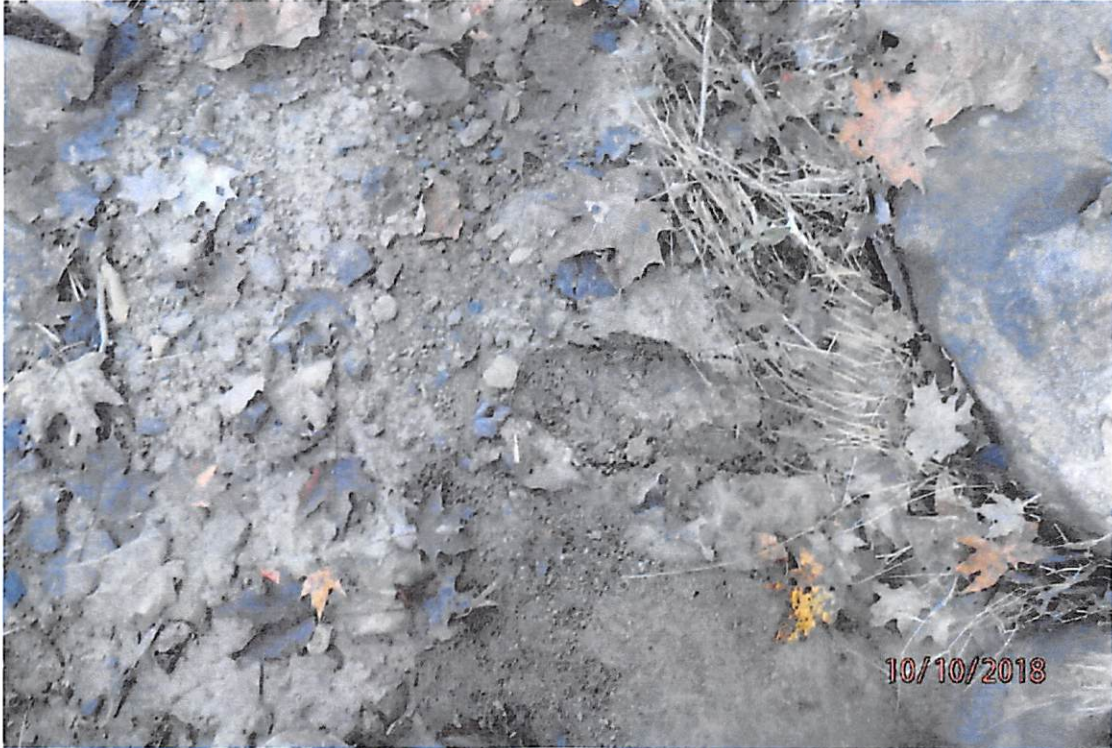
Installed water bar terminus BMP adjacent to 144+00 that caused offsite CNA deposits in UNT Morgans Run ($39^{\circ}18.509'$ X $80^{\circ}40.356'$).

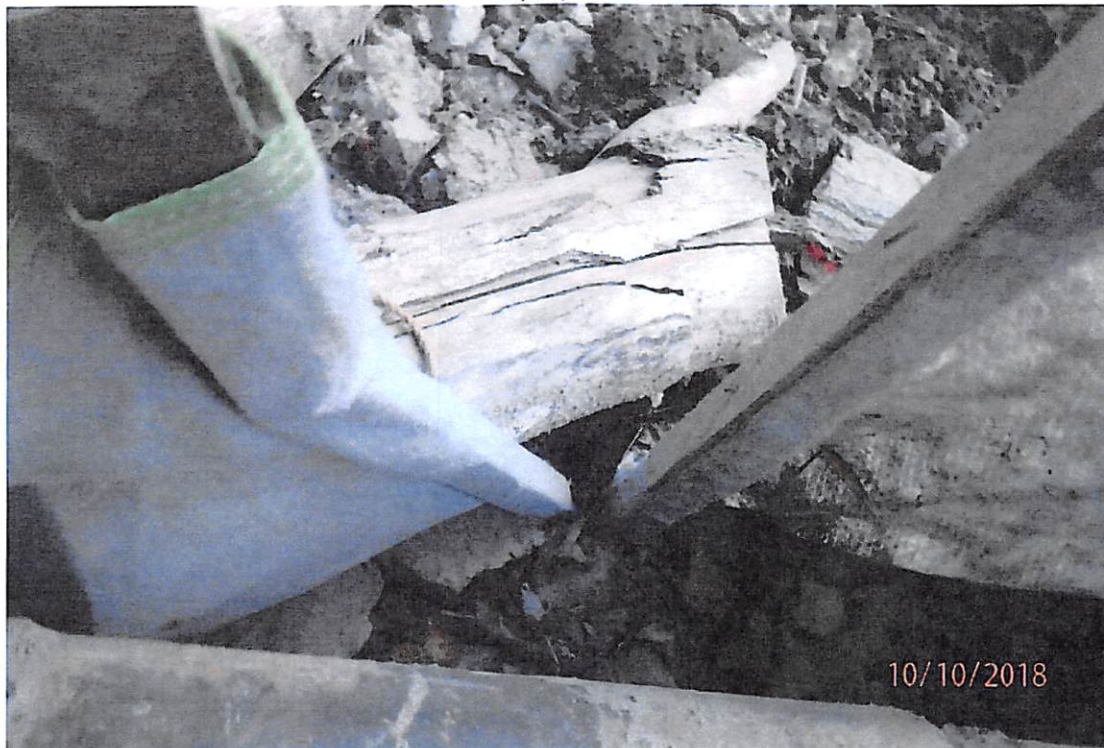
CNA deposits in UNT Morgans Run (39°18.509' X 80°40.356').

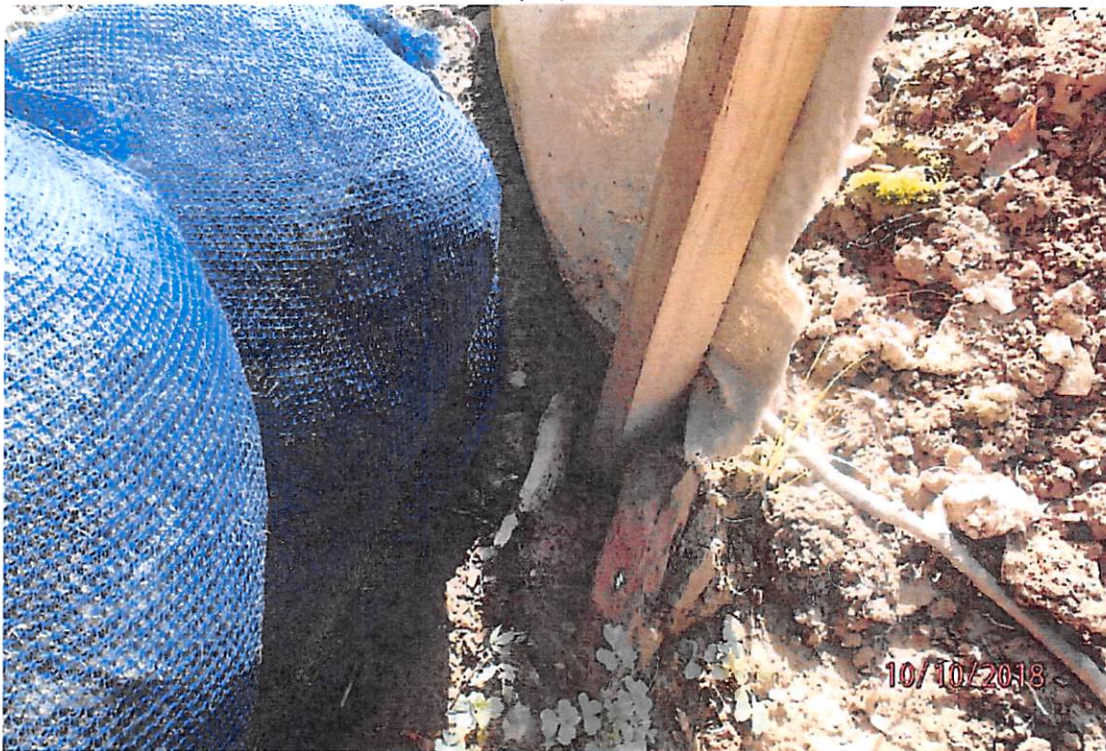
Improperly installed water bar terminus BMP in Wolfepen Run watershed.

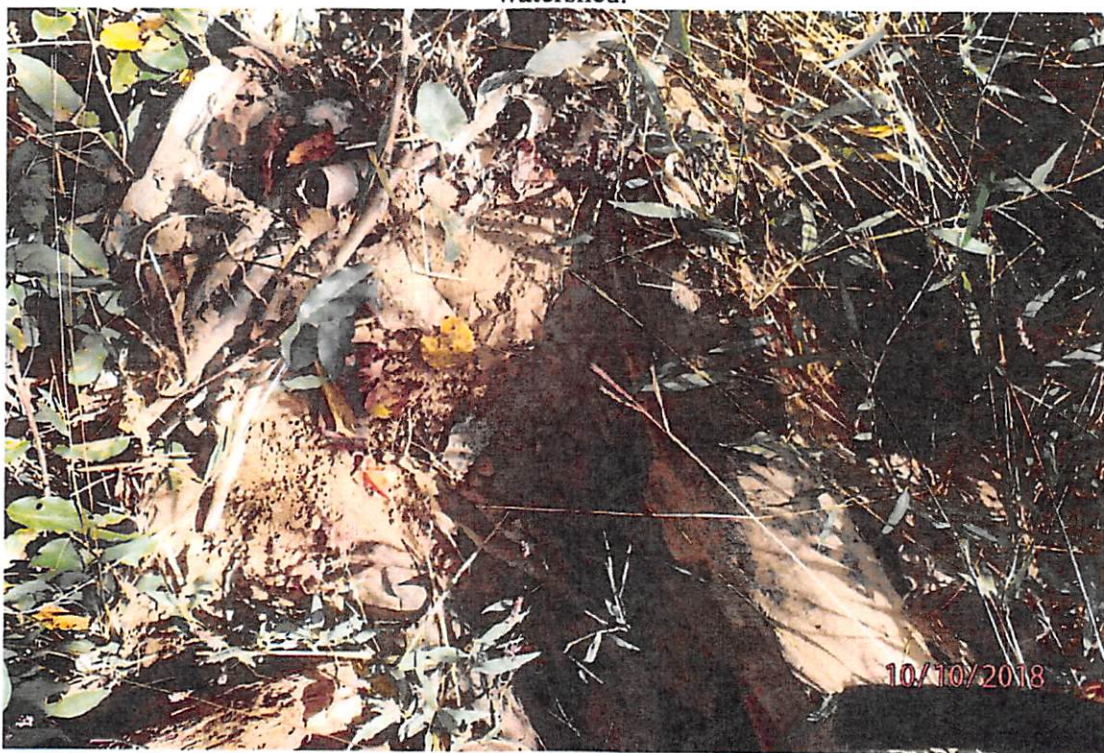
Improperly installed water bar terminus BMP which allowed offsite sediment deposits in Wolfpen Run watershed.

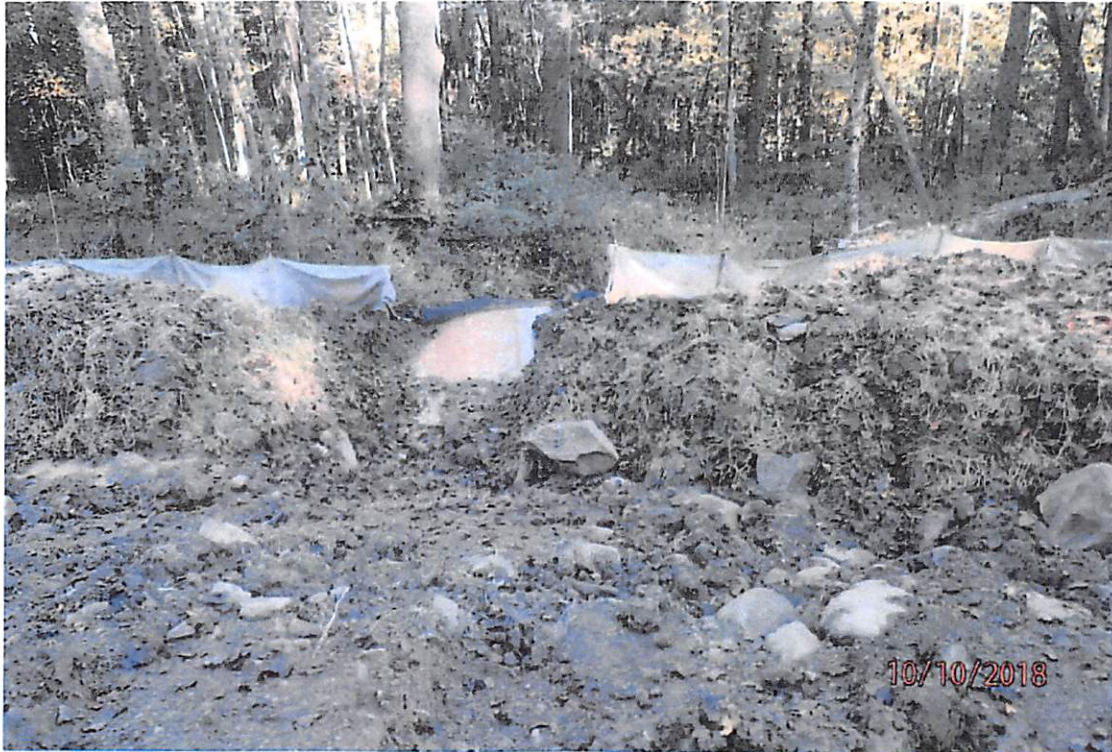
Offsite sediment deposits in Wolfpen Run watershed due to above pictured deficiency.

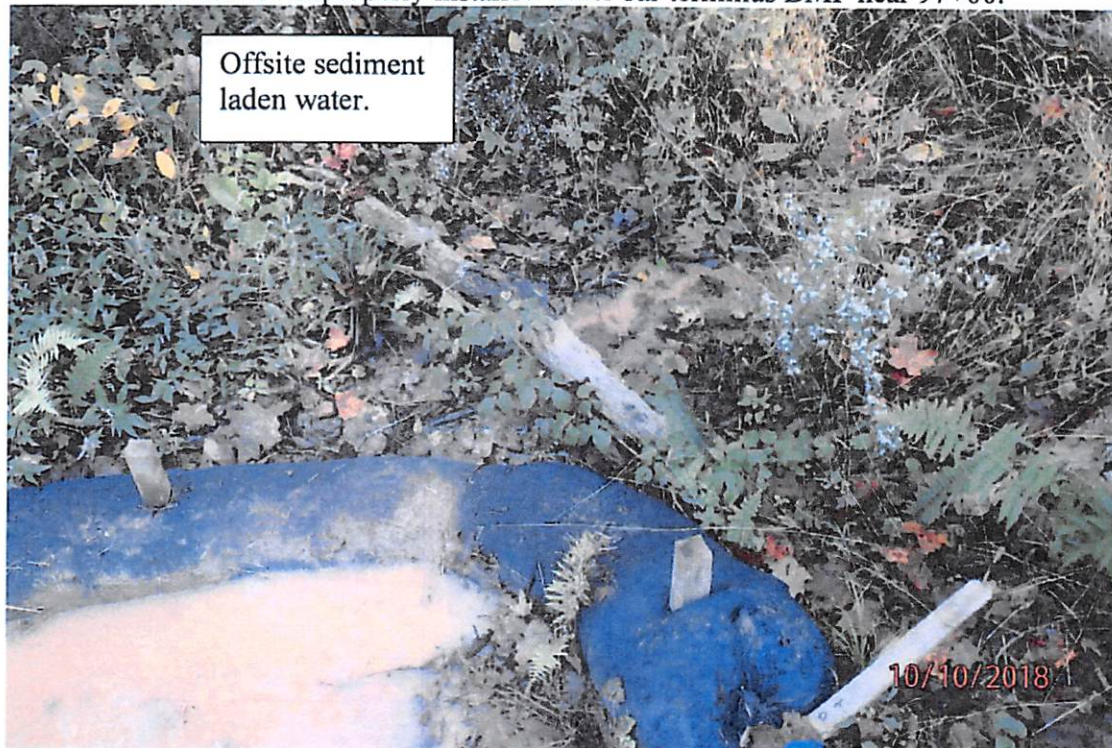
Overview of improperly installed water bar terminus BMP near 97+00.

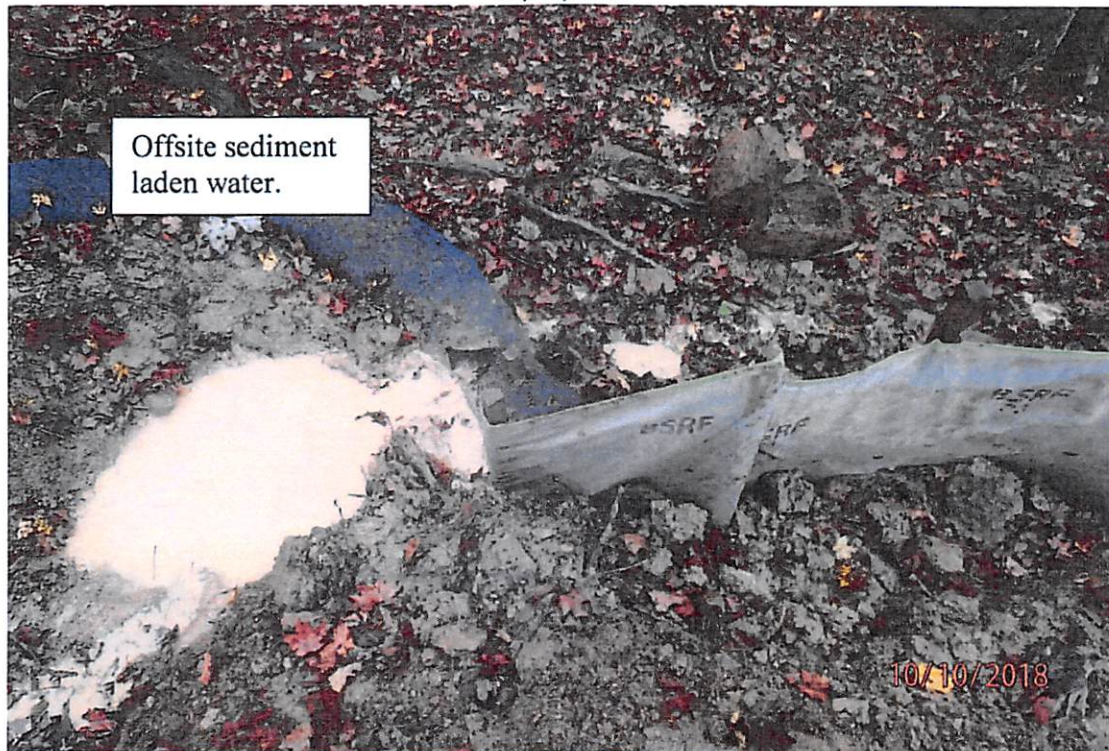
Improperly installed water bar terminus BMP which allows sediment laden water to bypass under the BMP near 97+00.

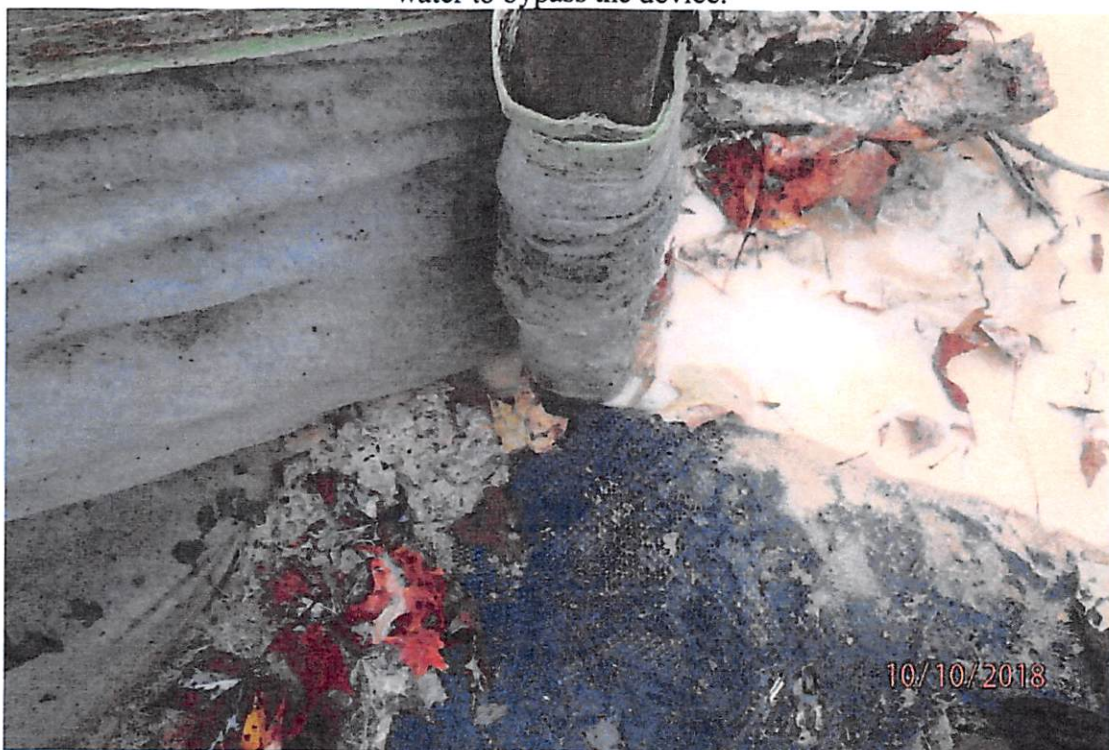
Improperly installed water bar terminus BMP in the Riggins Run watershed that allows sediment laden water to bypass the device.

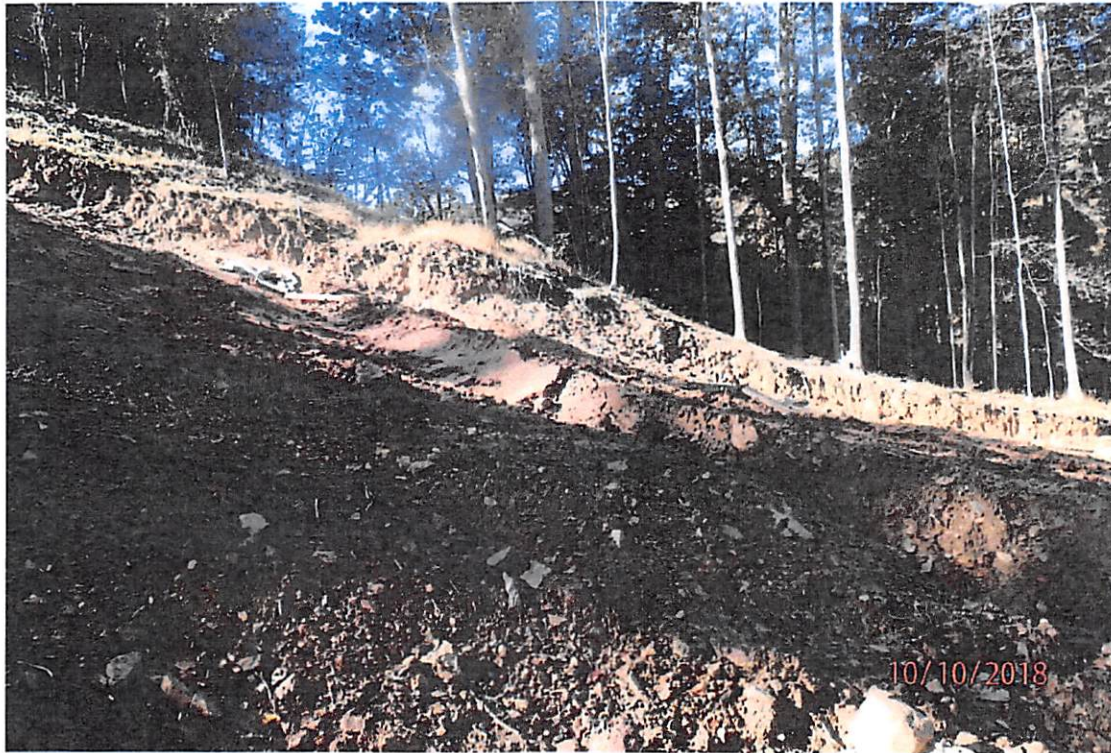
Improperly installed water bar terminus BMP in the Riggins Run watershed that allows sediment laden water to bypass the device.

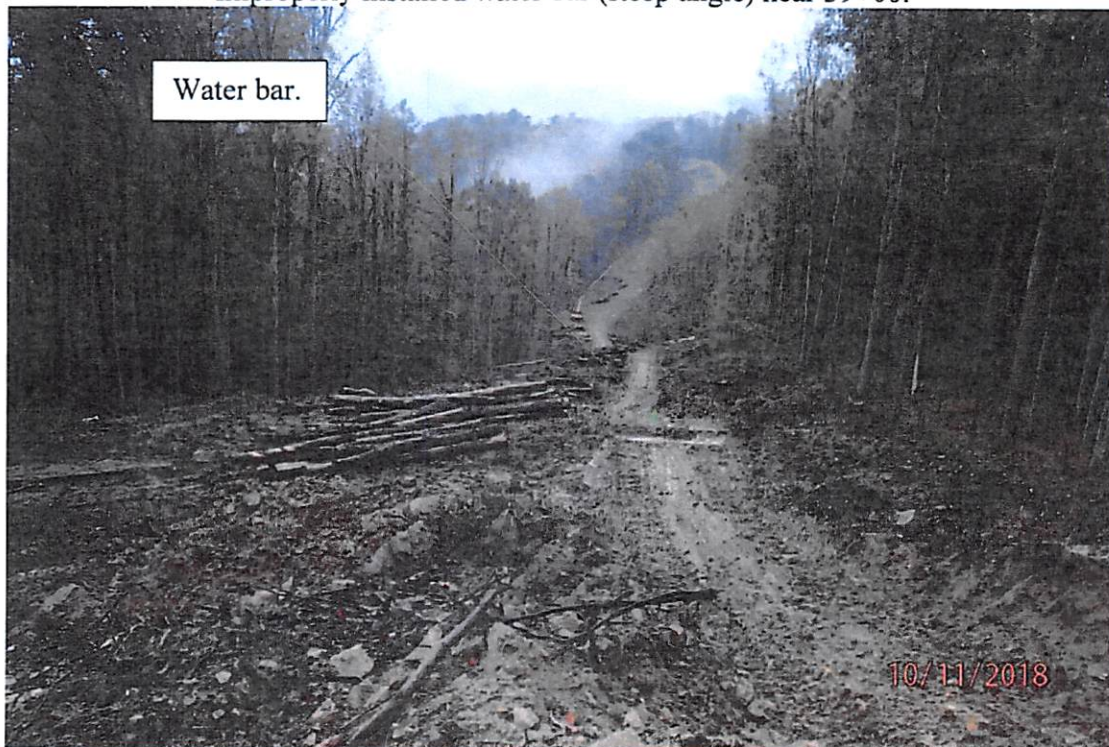
Improperly installed water bar (steep angle) near 39+00.

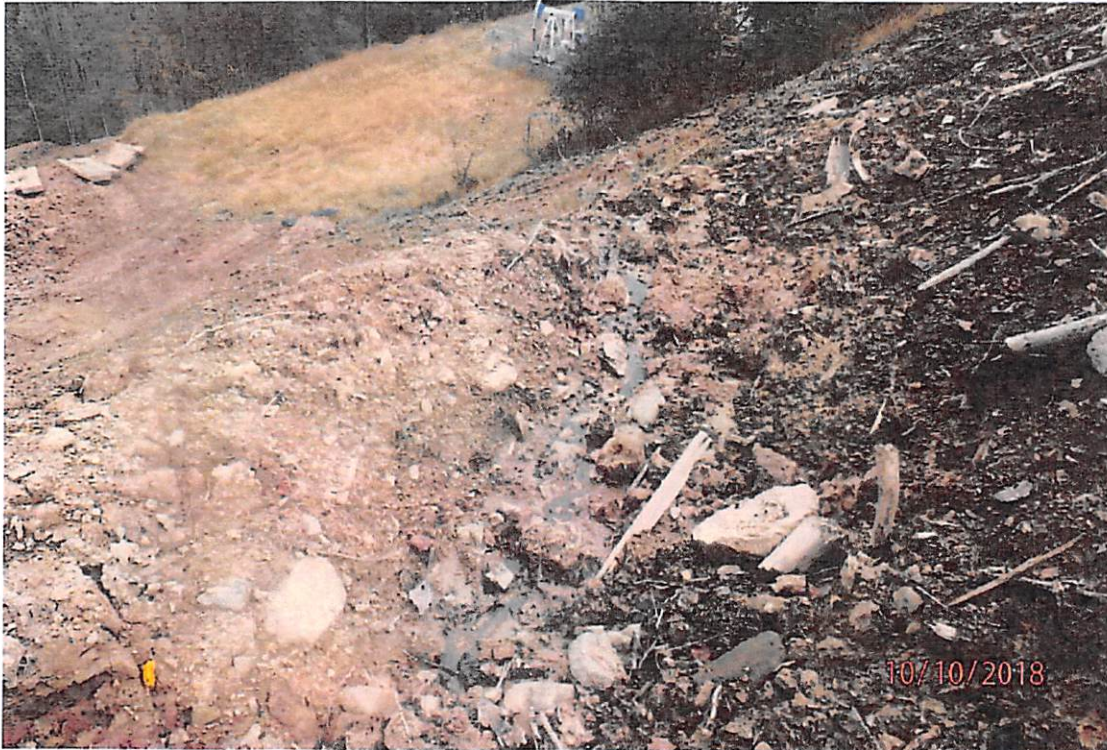
Improperly installed water (does not discharge off site as designed) near 551+00.

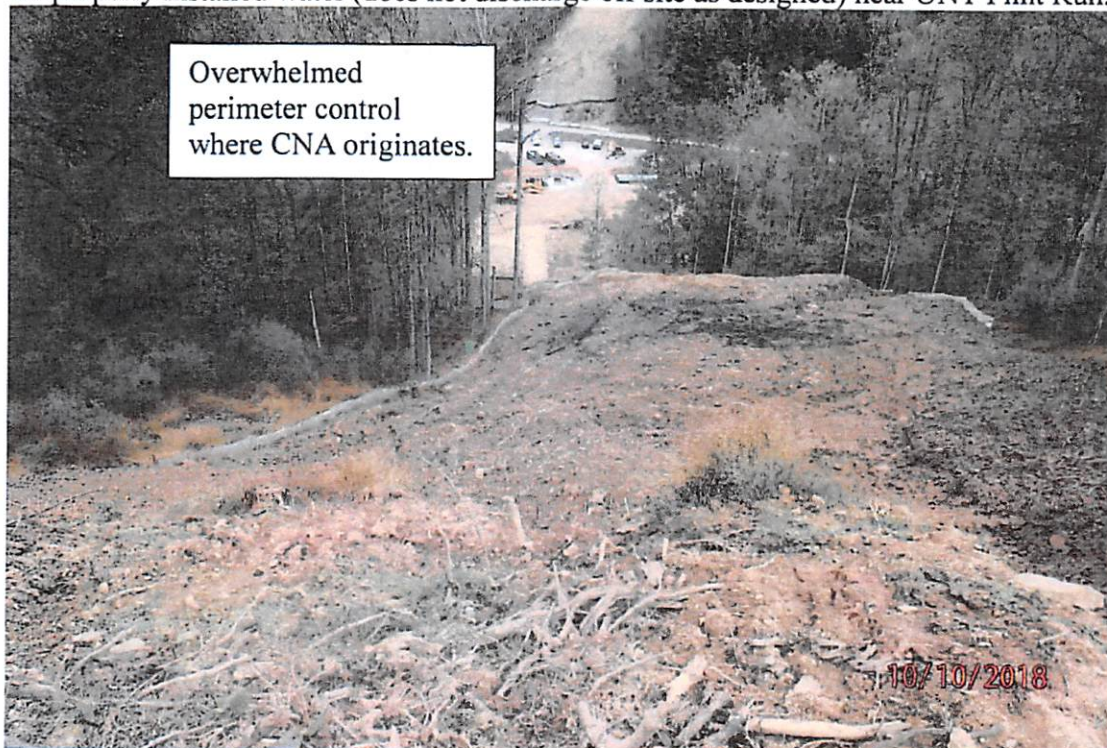
Improperly installed water (does not discharge off site as designed) near UNT Flint Run.

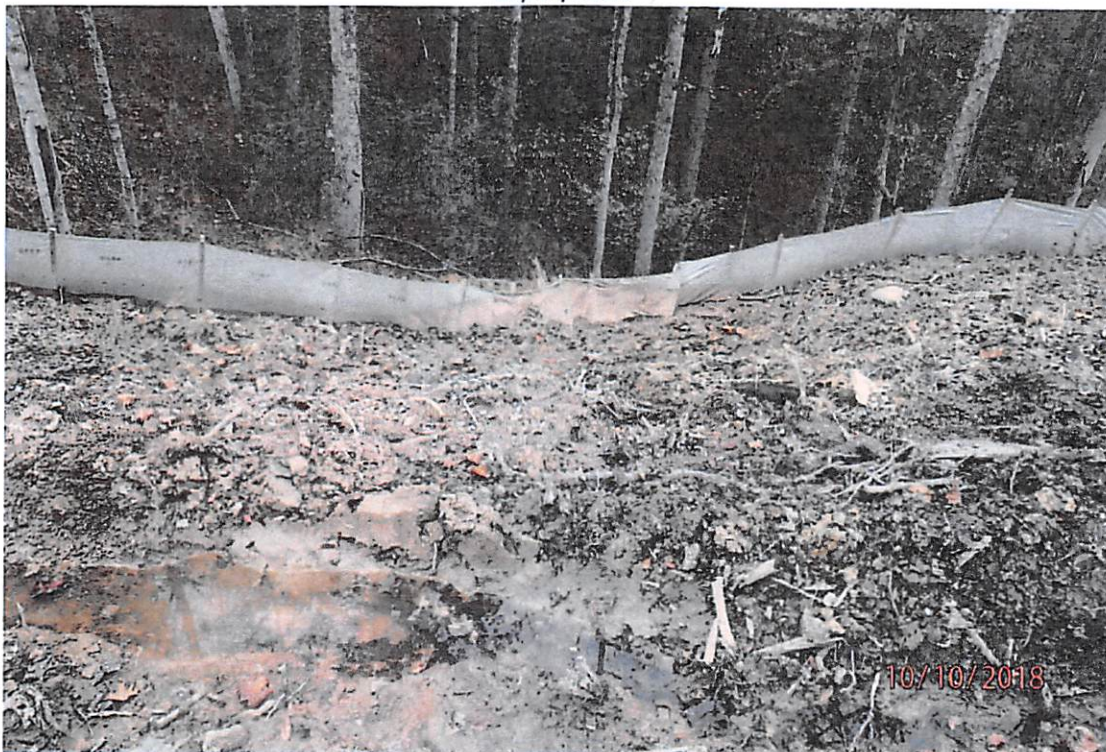
Area lacking properly installed water bars adjacent to UNT Flint Run. This caused excessive stormwater to overwhelm the installed BMP and caused CNA deposits in UNT Flint Run (39°20.058' X 80°39.931').

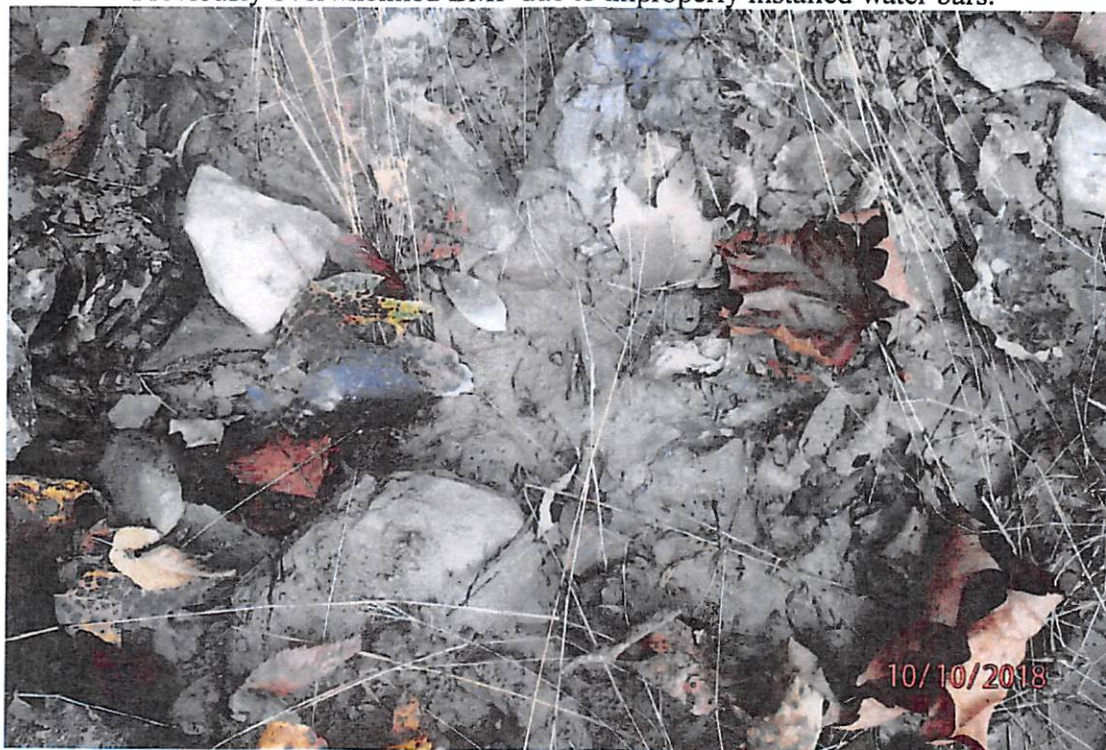
Previously overwhelmed BMP due to improperly installed water bars.

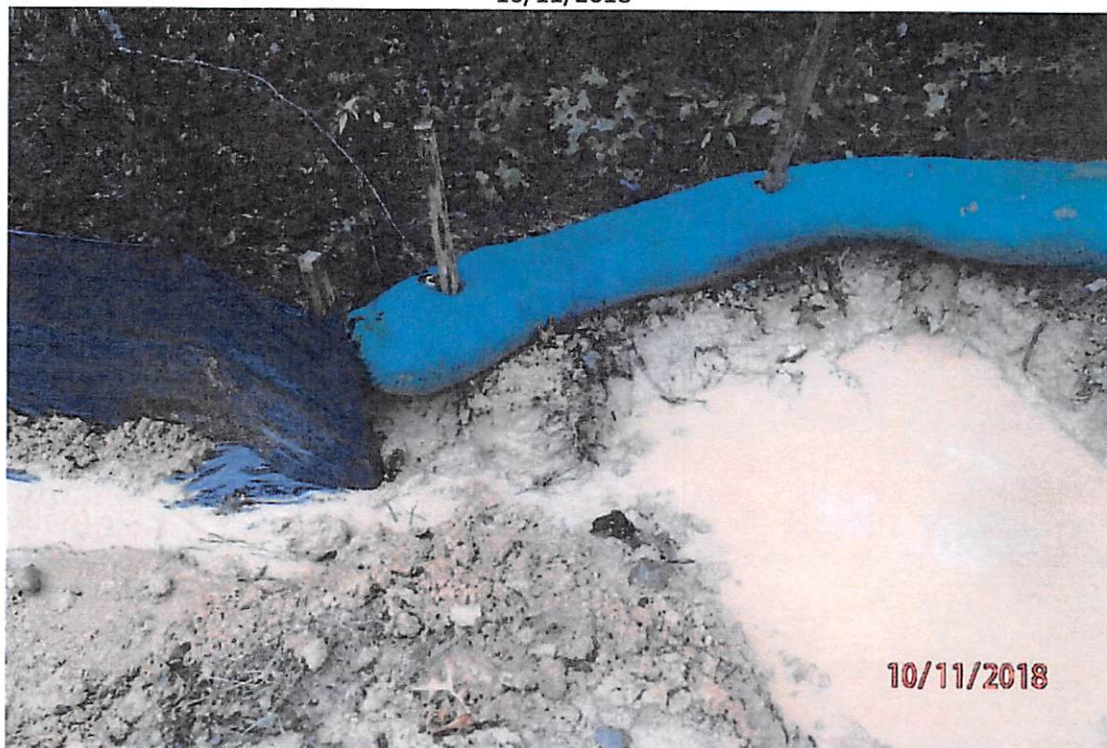
Offsite CNA deposits in UNT Flint Run (39°20.058' X 80°39.931').

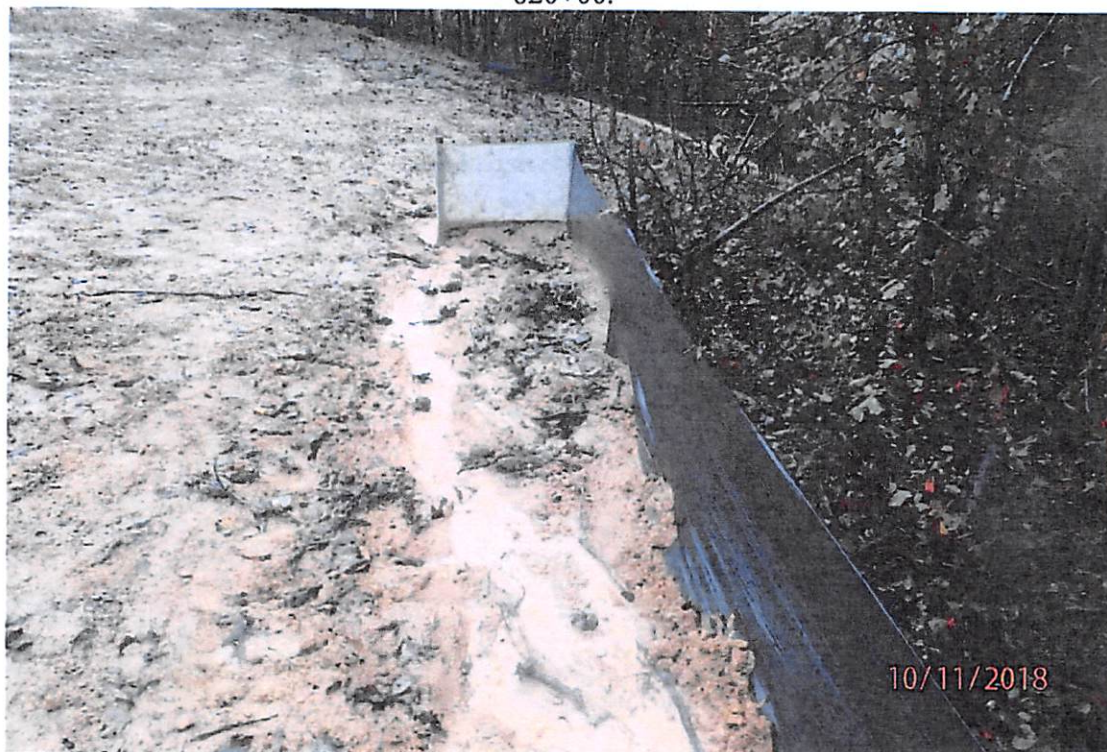
Improperly installed water bar that does not shed stormwater offsite in small quantities as designed near 820+00.

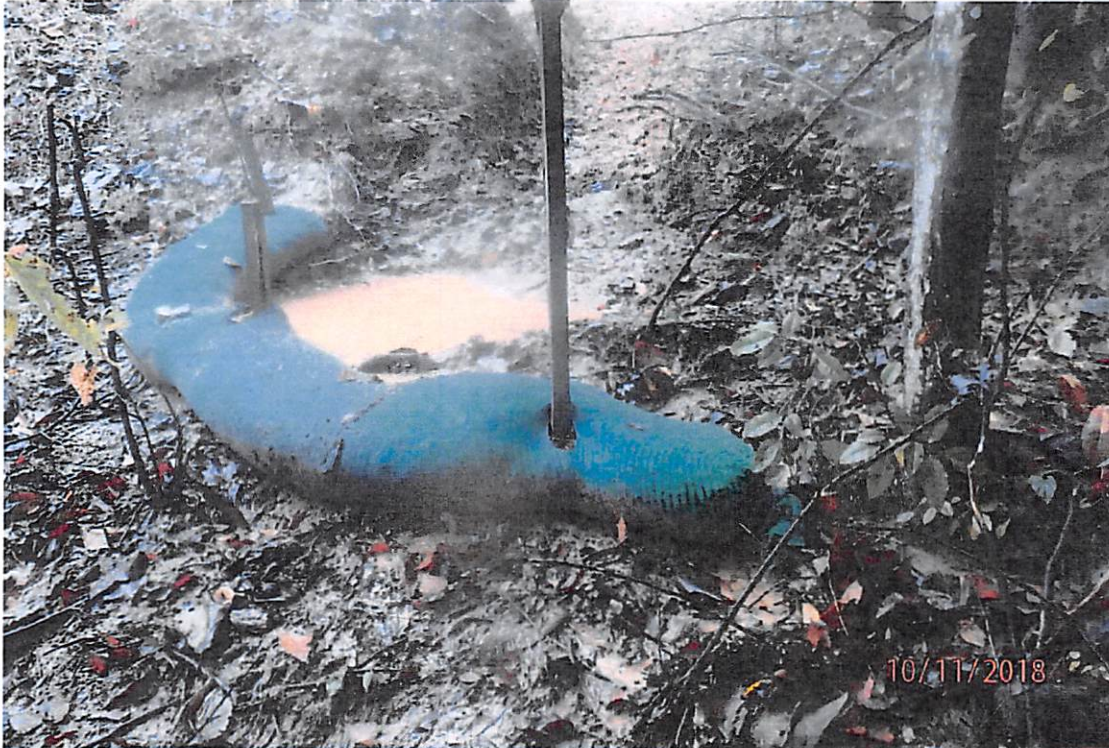
Sediment laden water bypassing perimeter controls adjacent to 820+00.
